KEDDY MILL, SOUTH WINDHAM, MAINE
CONCEPTUAL OPINION OF PROBABLE FOUNDATION REHABILITATION COSTS SUMMARY
February 11, 2009

KEDDY MILL, SOUTH WINDHAM, MAINE
CONCEPTUAL OPINION OF PROBABLE FOUNDATION REHABILITATION COSTS -- February 11, 2009

FORMER KEDDY MILL

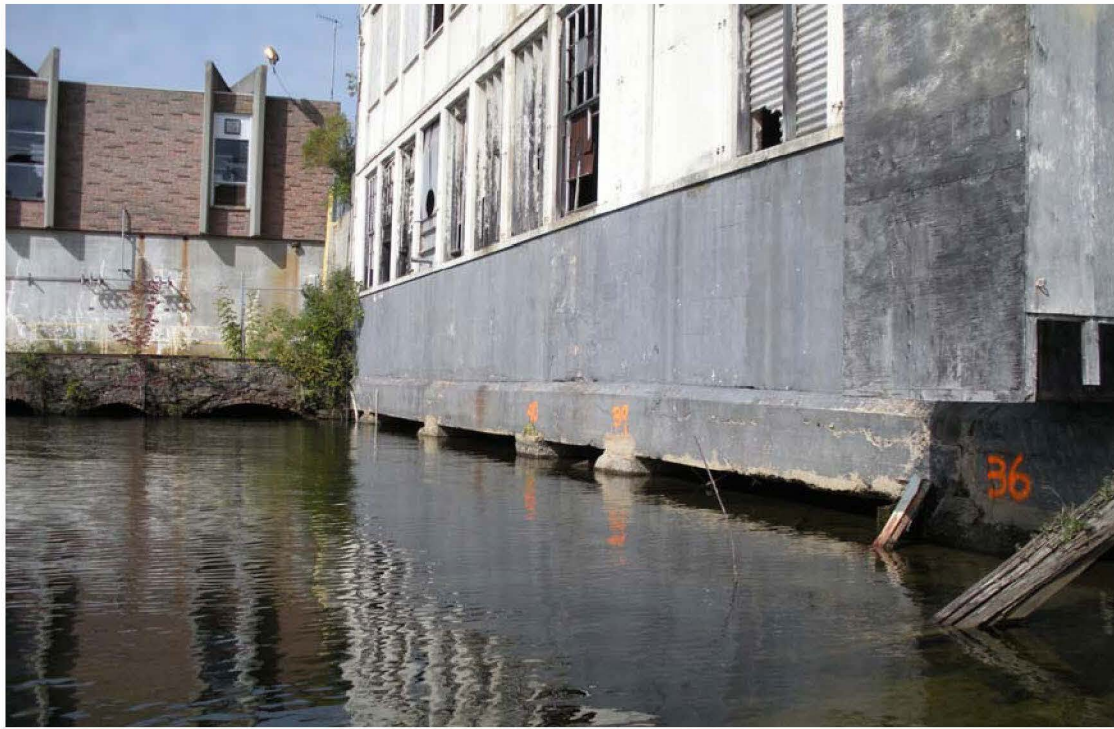
PHOTO
#2.1
923 001.jpg

Keddy Mill, South Wall: Pile Caps, Grade Beams, and Foundation Wall along South Wall, from Grid line 36 to grid line 47. Water depth limited access only to line 40.

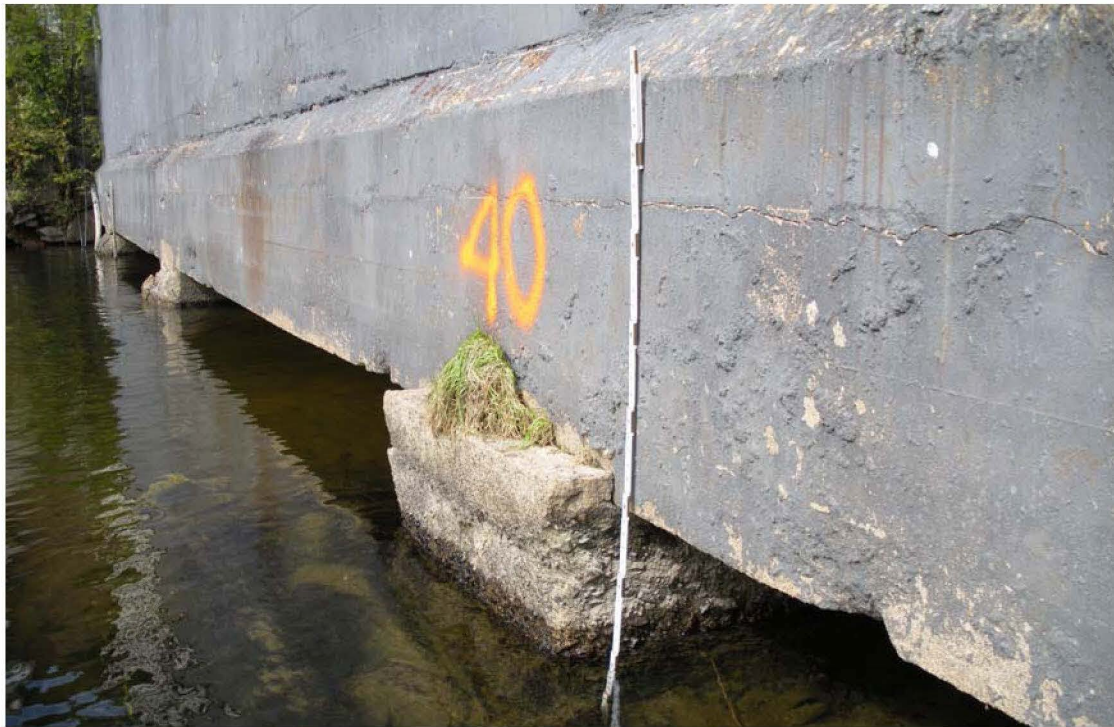
PHOTO
#2.2
923 032.jpg

Detail: South Wall Pile Cap at Line 40: Note horizontal grade beam crack. Pilecap is surrounded by a rotten wooden cofferdam visible in the water to the left of the pilecap. 12" clearance, water to bottom of grade beam.

4.3.1 Repair South Wall Grade Beam over Water											
Grade Beam Repairs, including swing staging over side of bldg	500	square feet	40.00	30.00	30.00	\$20,000	\$15,000	\$15,000	\$50,000		Equip provides allowance for access difficulty to water; i.e. swing staging
Assumes water has been lowered to allow underside access											See Photos #2.1 through #2.8
Does not consider any power plant stoppage costs											
Considers 167 feet x 3 feet = 501 square feet, round to 500 s.f.

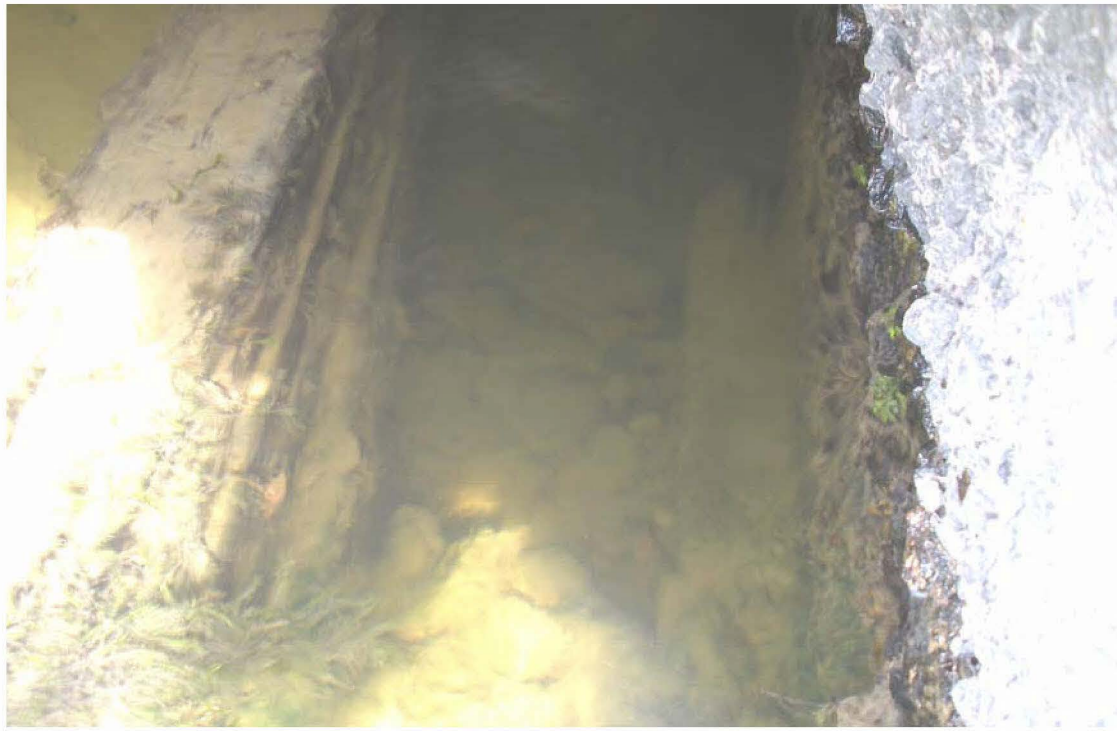
PHOTO
#2.3
923 042.jpg

South Wall Pile Cap, Line 40: Cofferdam at left, possible original formwork 2'-3" below water surface at right (arrow) may indicate bottom of pile cap.

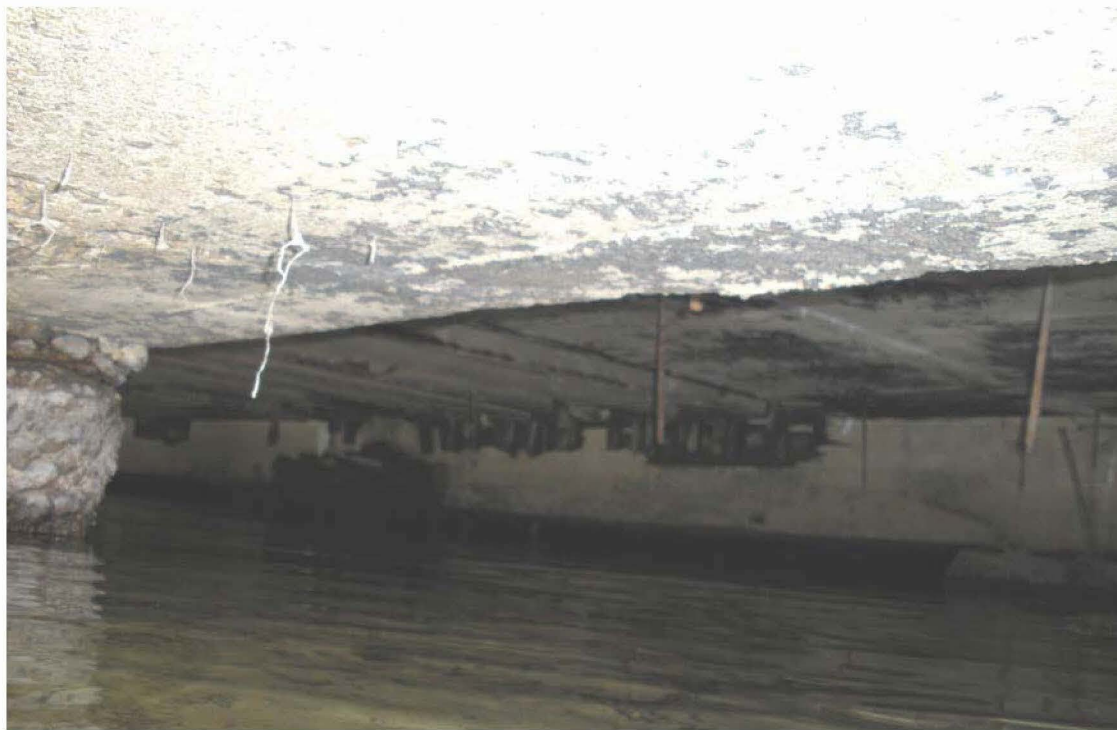
PHOTO
#2.4
923 046.jpg

South Wall, looking North: View of elevated slab underside. Pile Cap 40 at left. Note flat slab to Pile Cap 40, then slab-beam system from Column line 40 west to Column line 47.

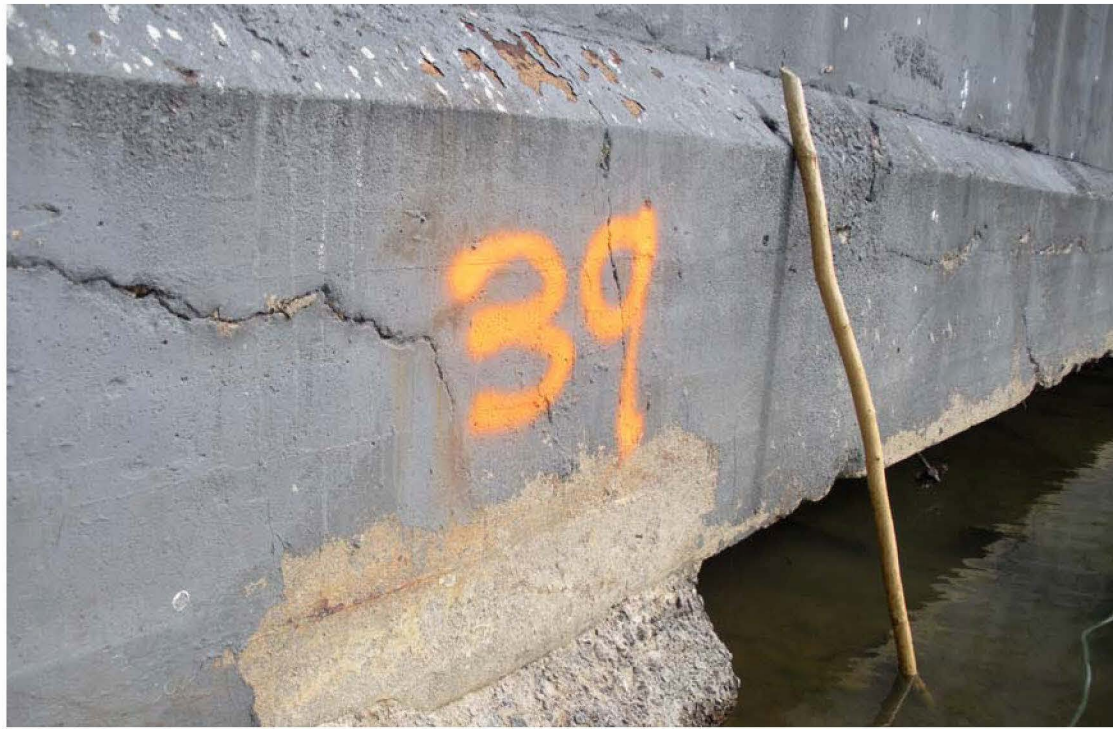
PHOTO
#2.5
923 026.jpg

South Wall Grade Beam at Pile Cap 39: Note cracking at left of photo, and crack beyond wading stick at right.

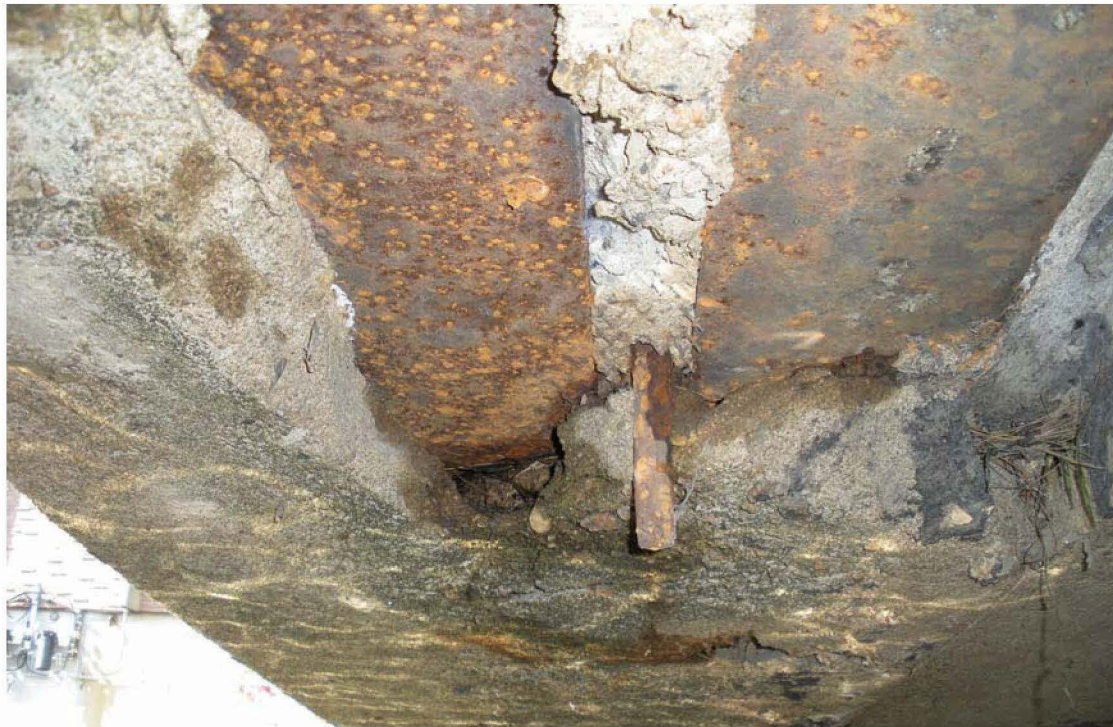
PHOTO
#2.6
923 048.jpg

South Wall Underside of Grade Beam, Looking from Line 36 to 39: Spalled concrete reveals structural steel plates, possibly the underside of wide-flange beams encased in concrete. Repair necessary. Cathodic protection possible.

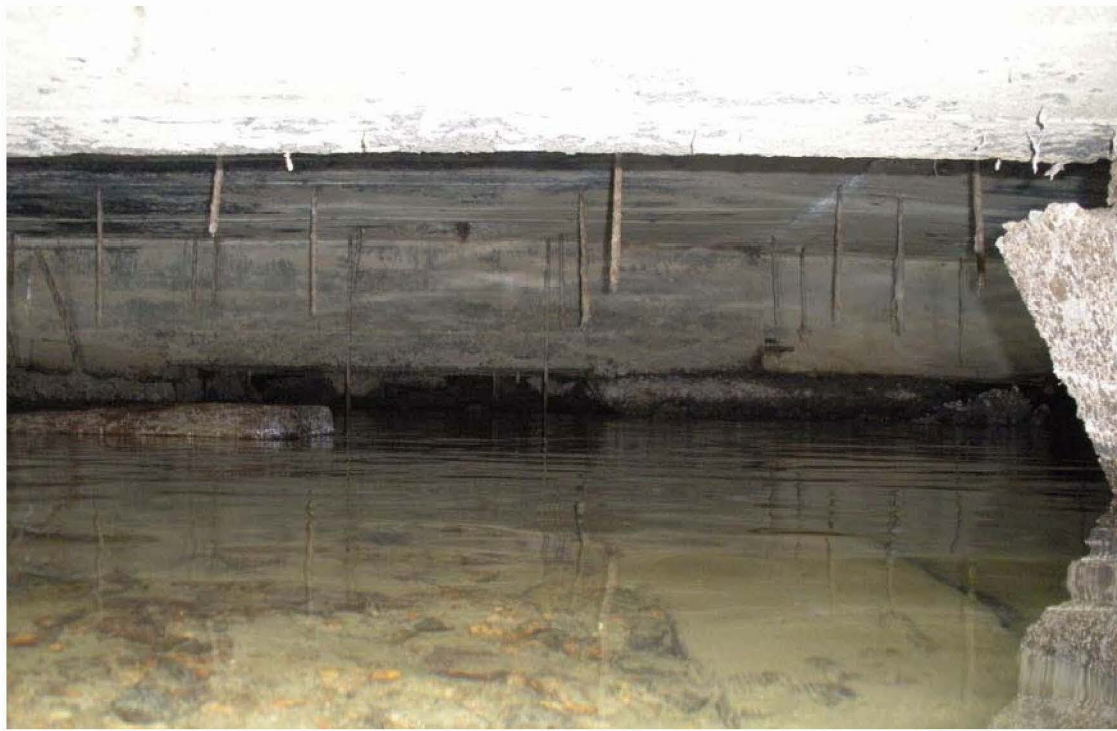
PHOTO
#2.7
923 045.jpg

South Wall: Slab Underside at Line 39: Note flat slab supported by grade beam and pile cap along interior line of framing.

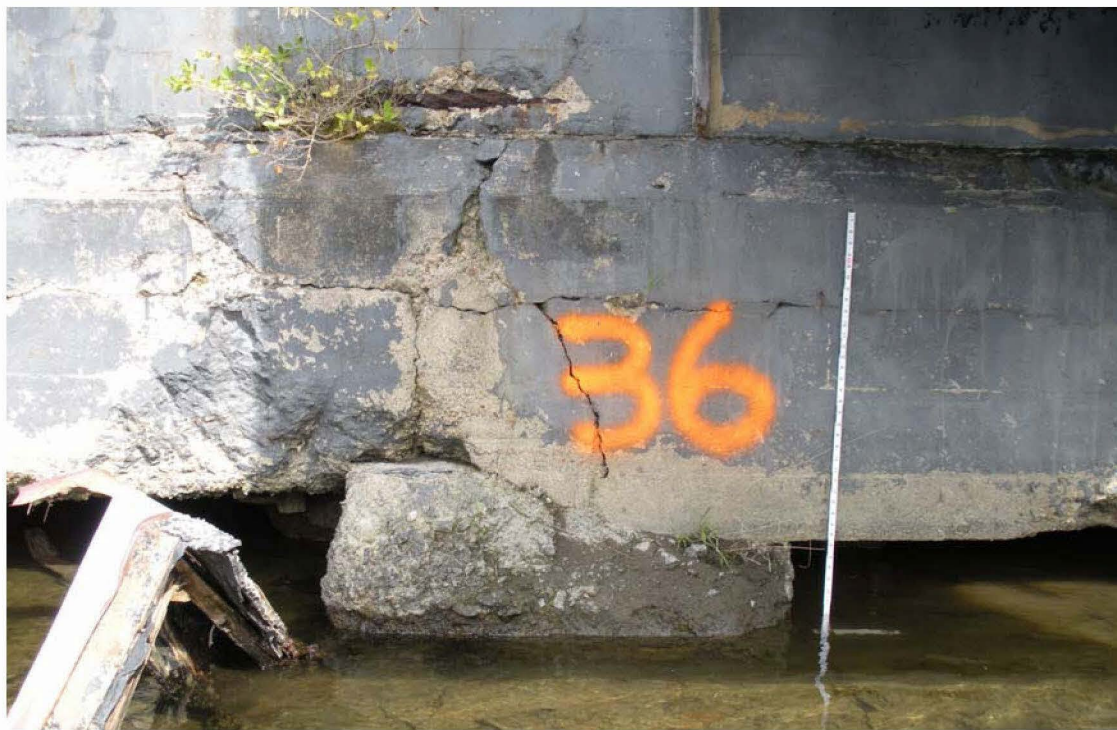
PHOTO
#2.8
923 010.jpg

South Wall Pilecap at Line 36: Note Cracking and Spalling of Concrete. Piece of bent metal at left partially obstructs view of grade beam. Repair required.

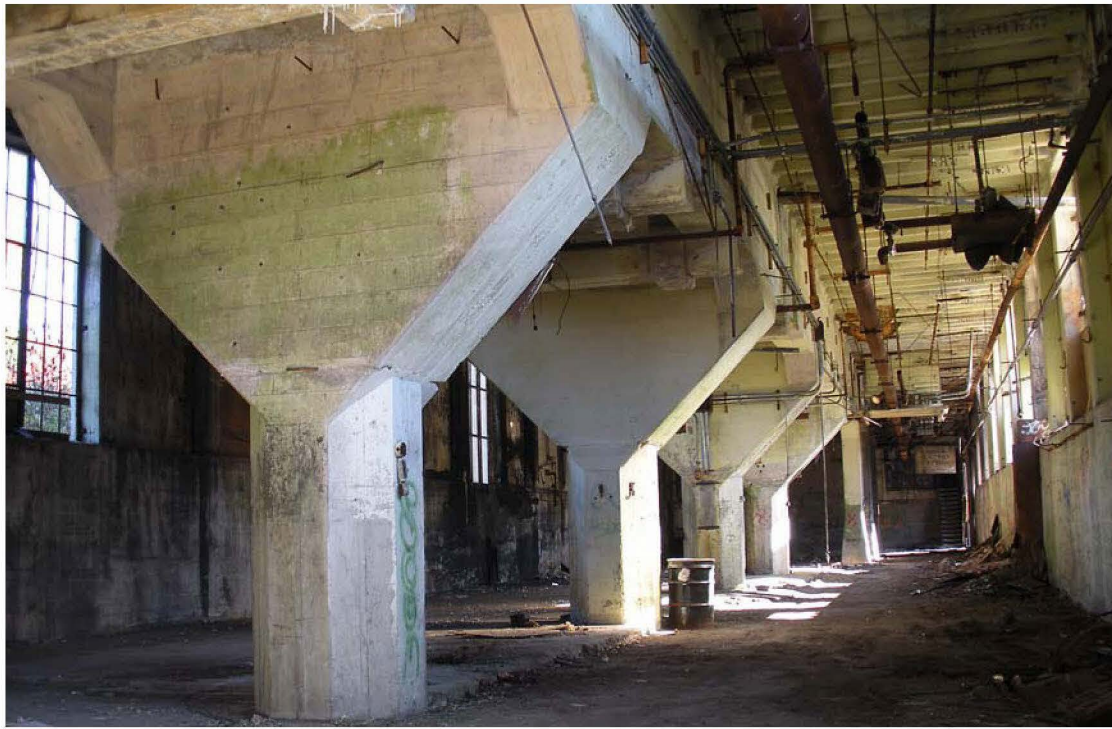
PHOTO
#3.1
oct 002.jpg

Keddy Mill, Basement: Proposed Parking Area. Note South Foundation Wall at Right. Columns on top of foundation wall can be braced across to center beam above triangular pier.

4.4.3 Brace Foundation Wall Tops, Lines 21-39, 6 locations											
Brace wall at Six Locations (at primary interior columns)	6	locations	1,400.00	1,400.00	200.00	\$8,400	\$8,400	\$1,200	\$18,000		See Photo #3.1 for Center Pier Structure
Considers steel braces diagonally from near tops of walls to Framework at Center of the Building	0	locations	0.00	0.00	0.00	\$0	\$0	\$0	\$0

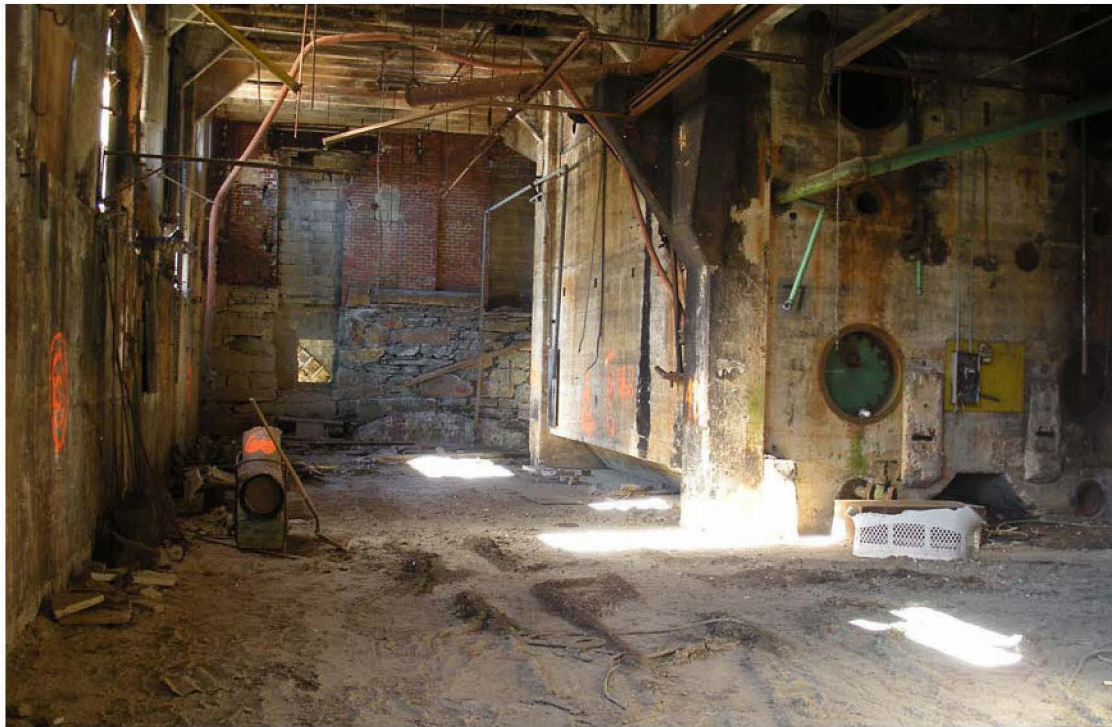
PHOTO
#3.2
923 032.jpg

Detail: Looking Toward West Retaining Wall: Rubble and brick are in poor condition, and should be stabilized. This wall should be supplemented and/or demolished and rebuilt. Also note thick silt deposits on elevated concrete slab.

4.4.4 New Retaining Wall at West End of the Building											
20 feet high x 76 feet long	1	lump sum	120,000.00	100,000.00	30,000.00	\$120,000	\$100,000	\$30,000	\$250,000		See Photo #3.2
considers some tiebacks into existing driveway soils and some bracing off of adjacent boiler structure to remain	0	locations	0.00	0.00	0.00	\$0	\$0	\$0	\$0
